# Intel<sup>®</sup> Itanium<sup>®</sup> 2 Processor

## Specification Update

Document Number: 251141-012

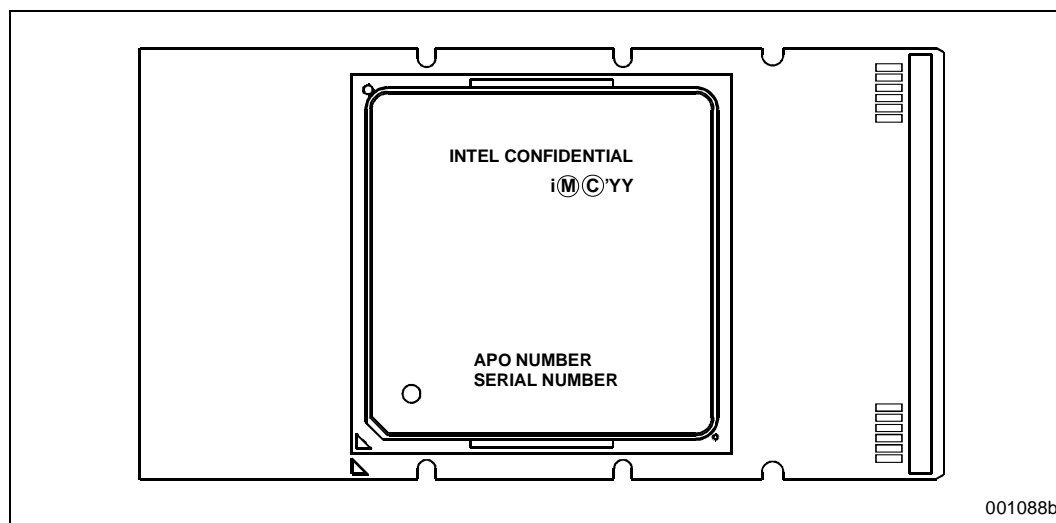
Figure 1-1. Processor Top-Side Marking on IHS

Figure 1-1 shows an example of the laser marking on the IHS. The processor top-side mark provides the following information:

- INTEL Brand/ INTEL Product
- Legal Mark
- Assembly Process Order (APO) Number
- Serial Number

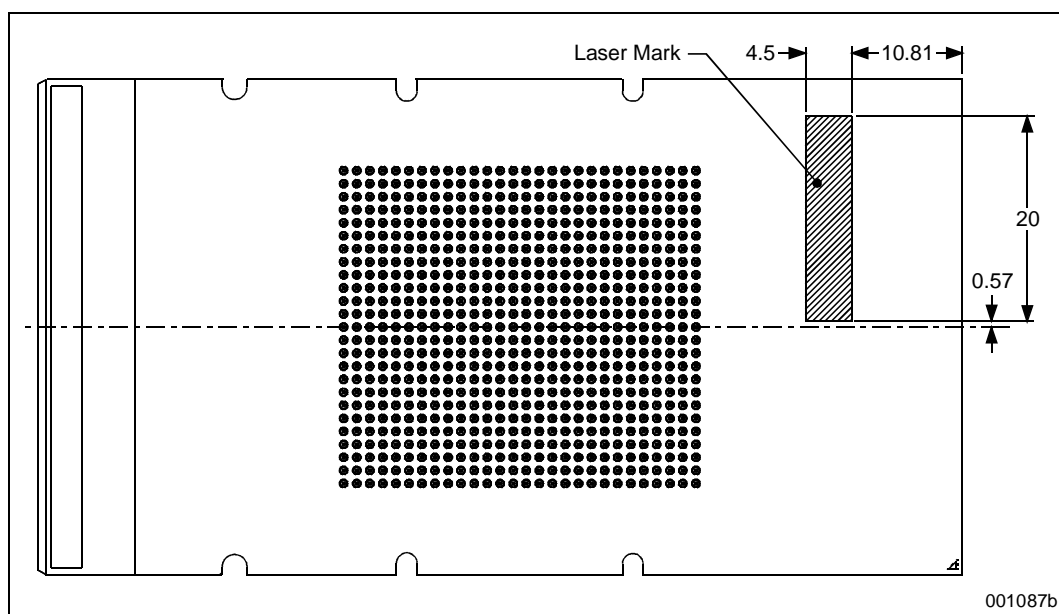
Figure 1-2. Processor Bottom-Side Marking Placement on Interposer

The processor bottom-side mark for the product is a laser marking on the pin side of the interposer. Figure 1-2 shows the placement of the laser marking on the pin side of interposer. The processor bottom-side mark provides the following information:

- Product ID
- Finish Process Order (FPO)
- Serial Number
- S-Spec
- Country of Origin
